**Flood Control Project Maintenance  
Levee Inspections****LMA District Cover Sheet****Spring 2016 Levee Inspection Results****Reclamation District No. 0150 Merrit Island**

**Spring 2016 Levee Inspection Results**

**Reclamation District No. 0150 Merrit Island**

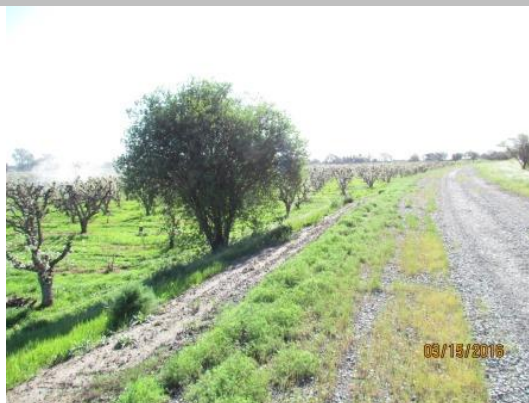
Photo 1 of 1 : SP\_2016\_RD0150\_15\_3\_20160318\_00006.jpg

View of the elderberry on the landside toe of the levee. The elderberry doesn't block visibility and it is trimmed up 5 feet above the slope.

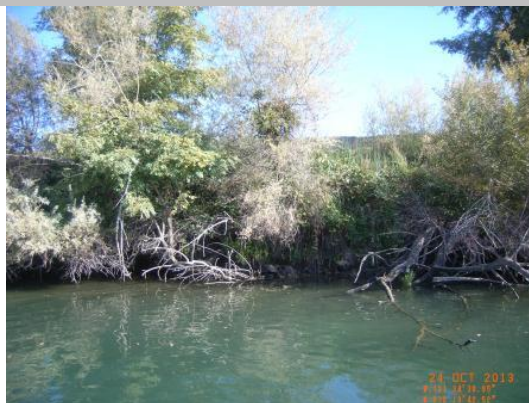
Photo 1 of 2 : SP\_2016\_RD0150\_15\_2\_20160219\_00001.jpg

LM Start	0.44	Rating **	M	Issue No.	2
LM End	0.49	Issue Type +	Ma	Location *	WS
Category	Supplemental			GPS Latitude/Longitude	
				Start	End
Item	2015 USACE Erosion Survey, DRAFT			38.328555 °	38.328020 °
				-121.577544 °	-121.576693 °
DWR ID	DWR_RD0150_01_s_2016_2				
Comment Code					
Inspector Comment					
2013 - Old toe repair unraveling. Bridge at upstream end of site. 2015: No observed changes. [2015 Site ID: STR_28-4_R]

USACE 2013 Photo #1

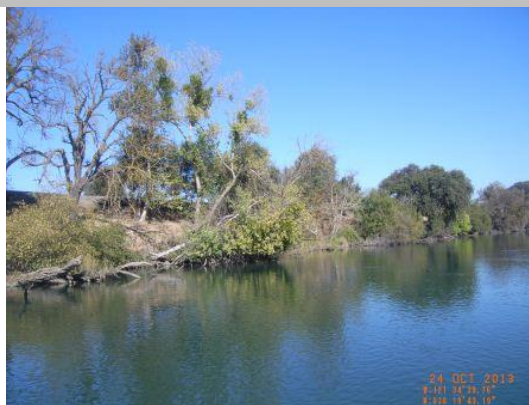
Photo 2 of 2 : SP\_2016\_RD0150\_15\_2\_20160219\_00002.jpg

USACE 2013 Photo #2

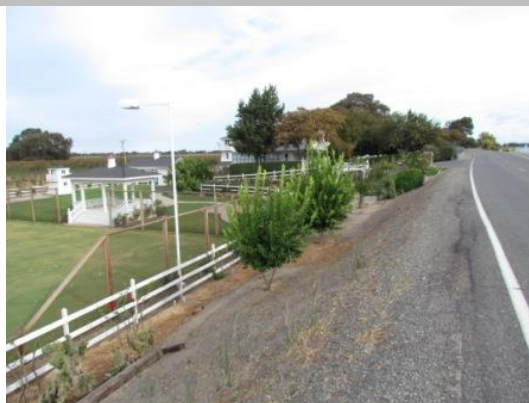
Photo 1 of 1 : SP\_2016\_RD0150\_16\_990\_20160219\_00054.jpg

Landscaping was found on the landside of the levee looking upstream.

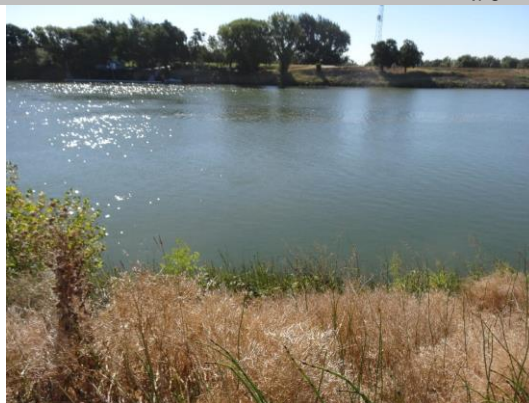
Photo 1 of 2 : UCIP\_SP\_2016\_42700\_34247.jpg

WS view: No pipe found on waterside slope. Dense vegetation on waterside.

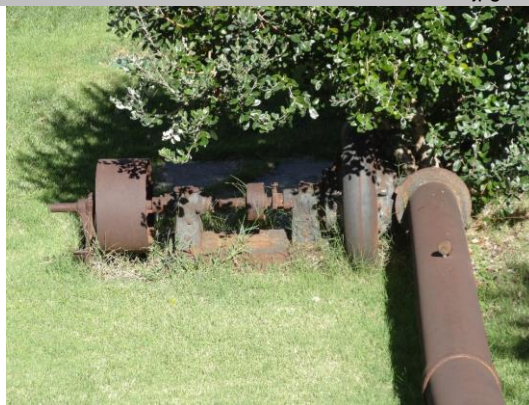
Photo 2 of 2 : UCIP\_SP\_2016\_42700\_34246.jpg

LS view: abandoned pipe and pump on landside toe.

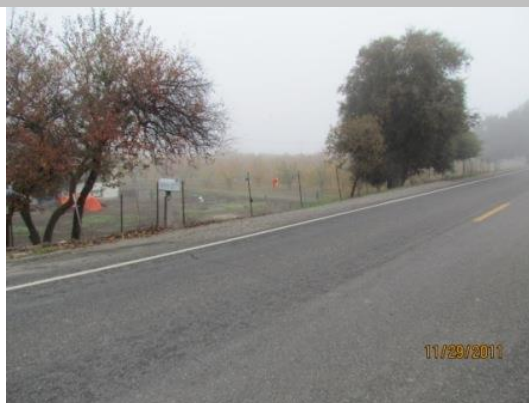
Photo 1 of 1 : SP\_2016\_RD0150\_16\_9\_20160219\_00005.jpg

Fence was found on the landside of the levee looking upstream.

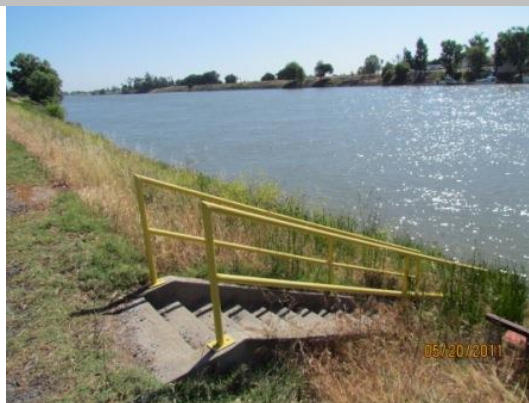
Photo 1 of 1 : SP\_2016\_RD0150\_16\_13\_20160219\_00008.jpg

LM Start	0.38	Rating **	M	Issue No.	13
LM End	0.38	Issue Type +	En	Location *	WS
Category	Earthen Levee			GPS Latitude/Longitude	
				Start	End
Item	Encroachments			38.332647 °	38.332647 °
				-121.572140 °	-121.572140 °
DWR ID	DWR_RD0150_02_s_2012_13				
Comment Code					
ST : Stairway					
Inspector Comment

A stairway was found on the waterside of the levee. The picture was taken from the crown looking upstream.

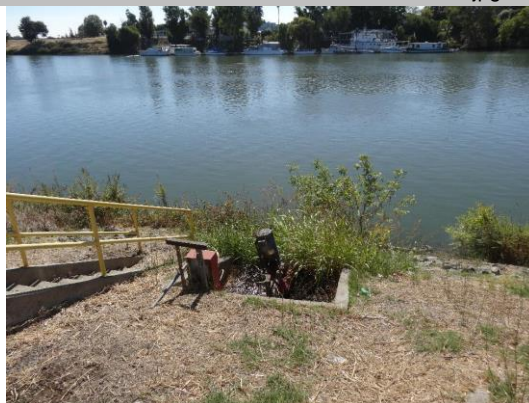
Photo 1 of 2 : UCIP\_SP\_2016\_20268\_34244.jpg

LM Start	0.39	Rating **	M	Issue No.	1003
LM End	0.39	Issue Type +	En	Location *	WS
Category	Supplemental			GPS Latitude/Longitude	
				Start	End
Item	DWR UCIP Field Study			38.332670 °	38.332670 °
				-121.572132 °	-121.572132 °
DWR ID					
Comment Code					
Inspector Comment					
FS_ID:20268					
DS_ID:22417					
EP_NO: N/A					
Repair Type: Non-Urgent					
Crossing Status: Found					
UCIP Comments: - Water leaks from pressure breaker.- Distribution box at the landward toe not found/visible.- Service pole on LS toe.					
FIELD_STRUCT_DESC: 4-inch steel pipe joined to 6-inch steel pipe and the 6-inch pppe joined to 10-inch steel pipe through the levee, 5.8 feet below the crown. 1.5-inch conduit through the levee, 3 feet below the crown. Pump and gate valve on the waterward slope. (Runyon).					
FS Date: 8/27/2013

WS view: walkway/stairs, pump on levee slope.

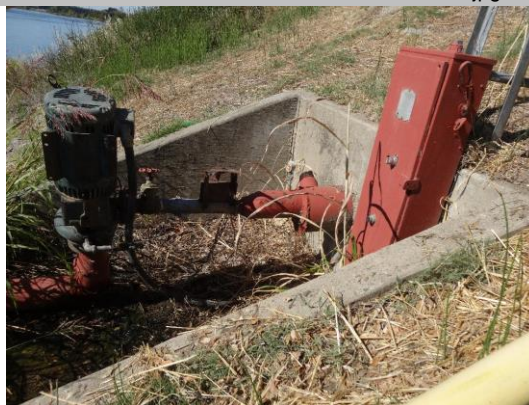
Photo 2 of 2 : UCIP\_SP\_2016\_20268\_34243.jpg

WS view: pump, electric control box, electric conduit on concrete pad.  
Water leaks from pressure breaker.

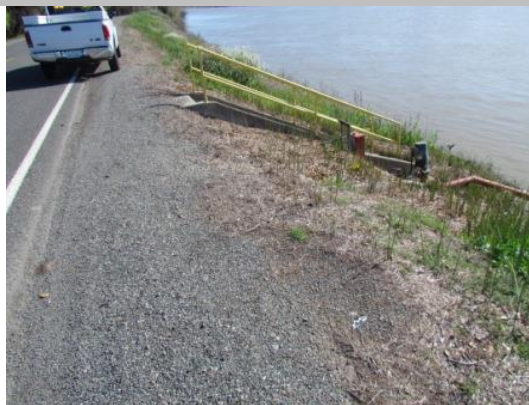
Photo 2 of 2 : SP\_2016\_RD0150\_16\_6\_20160219\_00003.jpg

LM Start	0.39	Rating **	M	Issue No.	6
LM End	0.39	Issue Type +	Ma	Location *	WS
Category	Earthen Levee			GPS Latitude/Longitude	
				Start	End
Item	Slope Stability			38.332717 °	38.332717 °
				-121.572083 °	-121.572083 °
DWR ID	DWR_RD0150_02_s_2012_6				
Comment Code					
S2 : Repair the levee slope damaged by foot traffic and prevent access where possible.					
Inspector Comment

Slope instability was found on the waterside of the levee looking upstream.

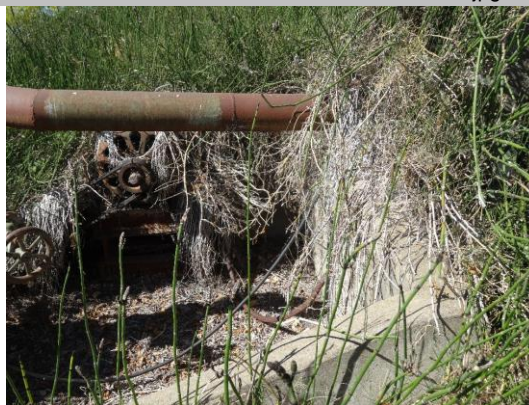
Photo 2 of 2 : UCIP\_SP\_2016\_20267\_34238.jpg

LM Start	0.46	Rating **	M	Issue No.	1002
LM End	0.46	Issue Type +	En	Location *	WS
Category	Supplemental			GPS Latitude/Longitude	
				Start	End
Item	DWR UCIP Field Study			38.333527 °	38.333527 °
				-121.571274 °	-121.571274 °
DWR ID					
Comment Code					
Inspector Comment					
FS_ID:20267					
DS_ID:22418					
EP_NO: N/A					
Repair Type: Non-Urgent					
Crossing Status: Found					
UCIP Comments: - Abandoned pipe and pump.- Needs proper abandonment.					
FIELD_STRUCT_DESC: 6-inch steel pipe and 1-inch conduit through the levee, 3.5 feet below crown, pump and gate valve on the waterward slope. Electric box on waterside slope. O&M Manual SAC 112, March 1957.					
FS Date: 8/27/2013

WS view: steel pipe and pump on concrete pad. Seems abandoned.

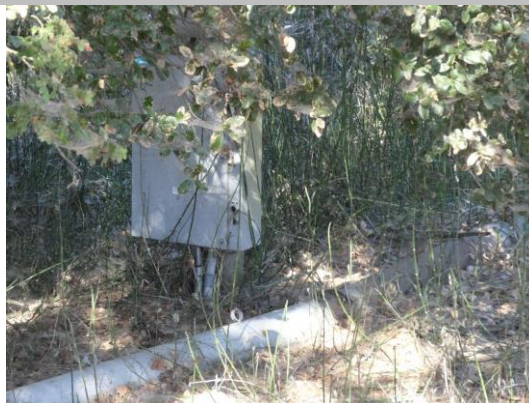
Photo 2 of 2 : UCIP\_SP\_2016\_20284\_34264.jpg

FS\_ID:20284  
DS\_ID:22419  
EP\_NO: N/A  
Repair Type: Non-Urgent  
Crossing Status: Found  
UCIP Comments: Needs proper abandonment.  
FIELD\_STRUCT\_DESC: 8-inch steel pipe through the levee, 5.7 feet below the crown. Power line on landside.(Mrs. J. Olson) O&M Manual SAC 112, March 1957.  
FS Date: 8/27/2013

LS view: exposed steel pipe and power pole on levee toe.

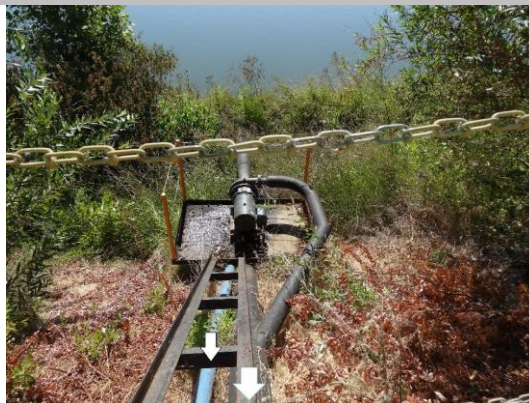
Photo 1 of 2 : UCIP\_SP\_2016\_20303\_34287.jpg

Comment Code					
Inspector Comment					
FS_ID:20303 DS_ID:22421 EP_NO: 16109 Repair Type: Non-Urgent Crossing Status: Found UCIP Comments: - 10" steel pipe on both sides of the levee. According to permit and inspectors note- 16" steel pipe through the levee.- concrete standpipe inside water filtration plant on landside toe.- air pressure tank on waterside steel deck. FIELD_STRUCT_DESC: 16 inch steel pipe and 2-inch conduit through the levee, 6.2 feet below the crown, slant pump on steel platform on the waterward slope. 4-inch abandoned pipe on the waterside slope. Concrete stand pipe and power pole at landside toe. (App. No. 18258, Wilson 2007) O&M Manual SAC 112, March 1957. FS Date: 8/27/2013

WS view: slant pump on steel deck, 4-inch pipe (left) and 10-inch pipe (right) on levee slope.

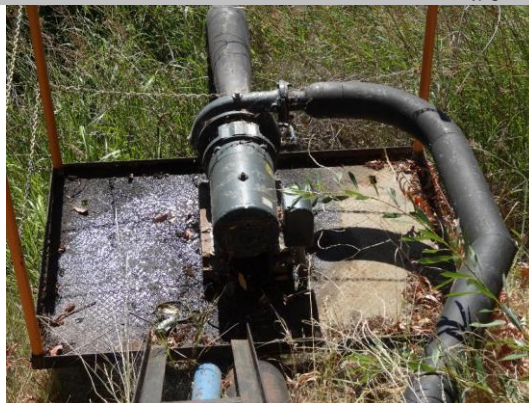
Photo 2 of 2 : UCIP\_SP\_2016\_20303\_34286.jpg

WS view: steel pipes and leaky slant pump on steel deck.

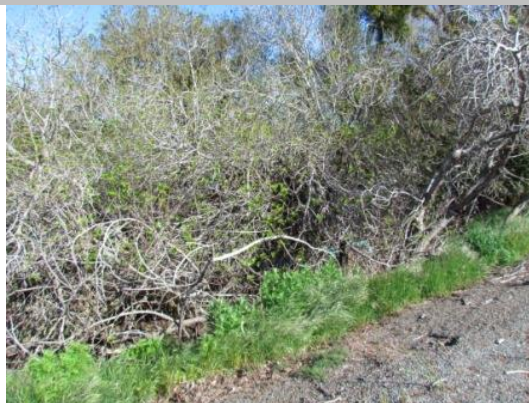
Photo 1 of 1 : SP\_2016\_RD0150\_16\_12\_20160219\_00007.jpg

LM Start	0.71	Rating **	M	Issue No.	59
LM End	0.71	Issue Type +	Ma	Location *	LS
Category	Earthen Levee			GPS Latitude/Longitude	
				Start	End
Item	Encroachments			38.336291 °	38.336291 °
				-121.568260 °	-121.568260 °
DWR ID	DWR_RD0150_02_s _ 2016_59				
Comment Code					
TR : Tree or limb					
Inspector Comment					
Damaged tree roots and trunks appear to damage landside slope of the levee.

Overgrown trees were obstructing the landside slope of the levee looking upstream.

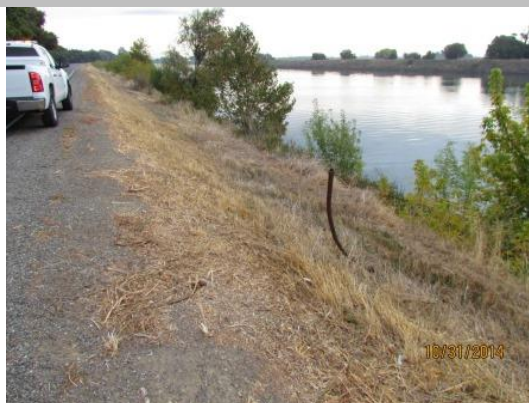
Photo 1 of 1 : SP\_2016\_RD0150\_16\_48\_20160219\_00025.jpg

LM Start	1.73	Rating **	M	Issue No.	48
LM End	1.73	Issue Type +	En	Location *	WS
Category	Earthen Levee			GPS Latitude/Longitude	
				Start	End
Item	Encroachments			38.345583 °	38.345583 °
				-121.554507 °	-121.554507 °
DWR ID	DWR_RD0150_02_f_2014_48				
Comment Code					
PO : Pole					
Inspector Comment					
A pole was found on the waterside slope of the levee. Most probably is connected to a pump.

A pole/pipe was found on the waterside slope of the levee looking upstream.

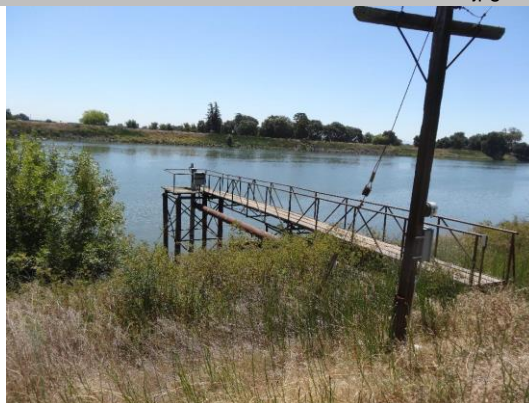
Photo 1 of 2 : UCIP\_SP\_2016\_20348\_34371.jpg

WS view: service pole, pipe &amp; pump on piling structure in the stream.

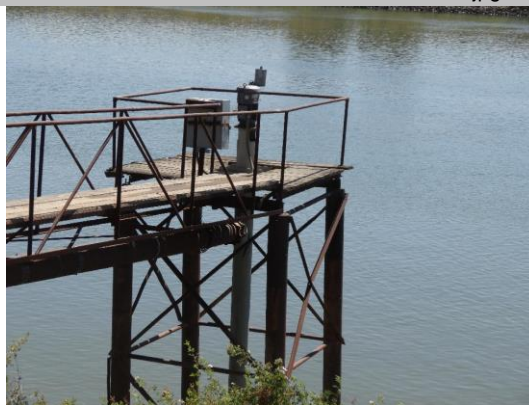
Photo 2 of 2 : UCIP\_SP\_2016\_20348\_34370.jpg

WS view: pipe &amp; pump on piling structure in the stream.

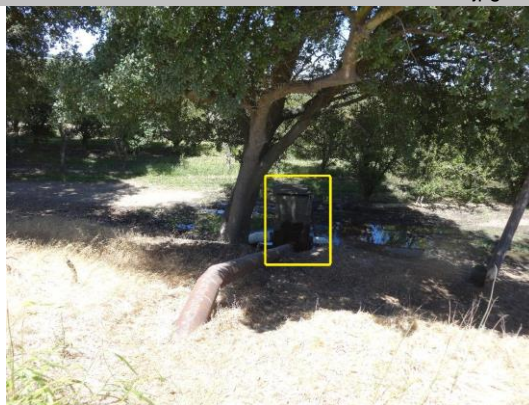
Photo 2 of 2 : UCIP\_SP\_2016\_20731\_34901.jpg

LS view: concrete distribution box on levee toe and exposed steel pipe on levee slope.

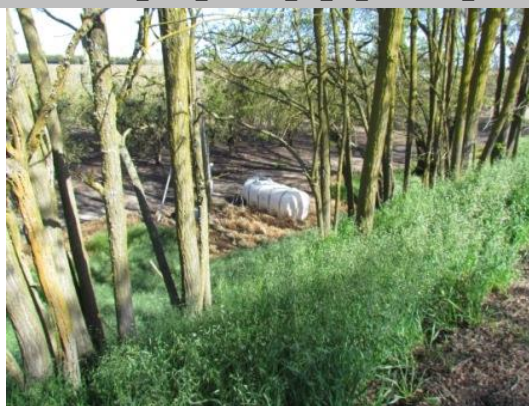
Photo 1 of 1 : SP\_2016\_RD0150\_16\_23\_20160219\_00013.jpg

A tank was found on the landside toe of the levee looking upstream.

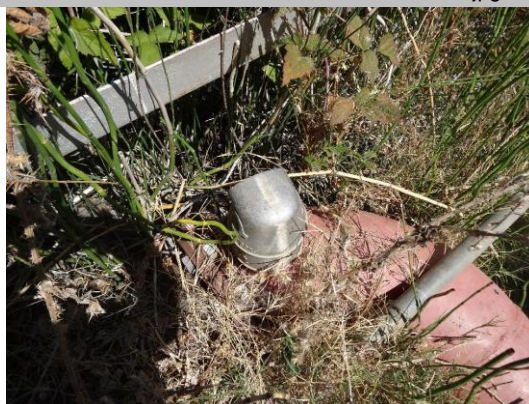
Photo 2 of 2 : UCIP\_SP\_2016\_20732\_34905.jpg

WS view: air vent on steel pipe on levee slope. Electric conduit over pipe (right)

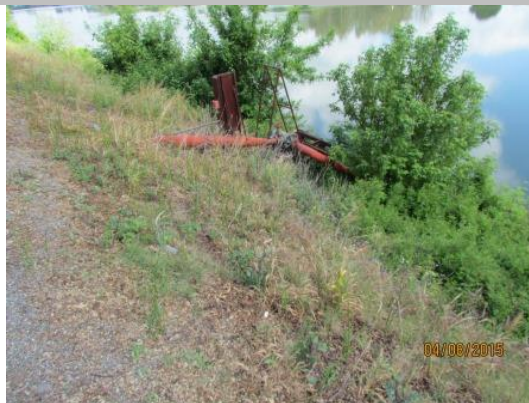
Photo 1 of 5 : SP\_2016\_RD0150\_16\_961\_20160219\_00047.jpg

Updated picture of the erosion on the waterside of the levee during spring 2015 inspection.

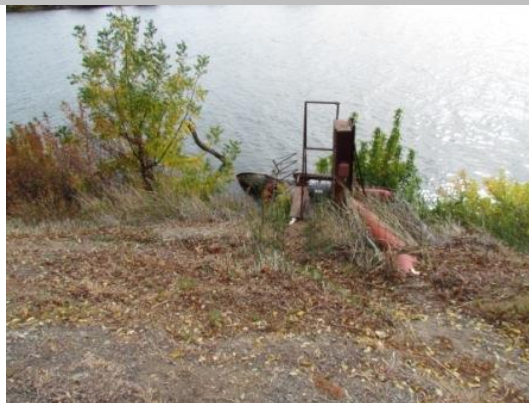
Photo 4 of 5 : SP\_2016\_RD0150\_16\_961\_20160219\_00050.jpg

View of erosion and damaged pipe and abandoned boat on the waterside of the levee looking upstream. This picture was taken during fall 2012 inspection.

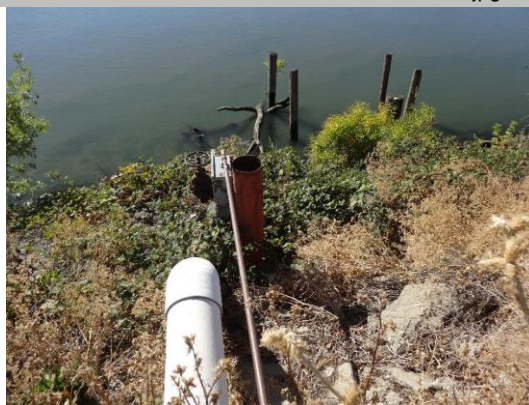
Photo 1 of 2 : UCIP\_SP\_2016\_19846\_33727.jpg

WS view: pipe, pump, and conduit on levee slope.

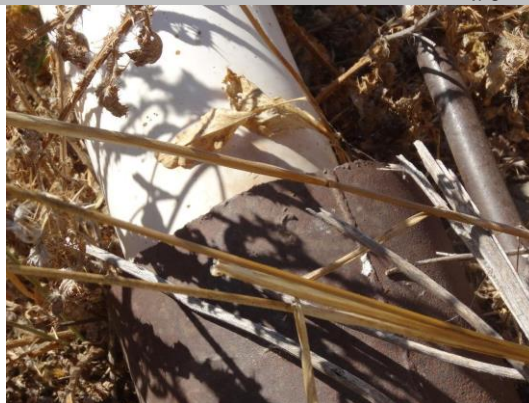
Photo 2 of 2 : UCIP\_SP\_2016\_19846\_33726.jpg

WS view: steel conduit (right); 8" pvc pipe sleeved into 12" steel pipe.

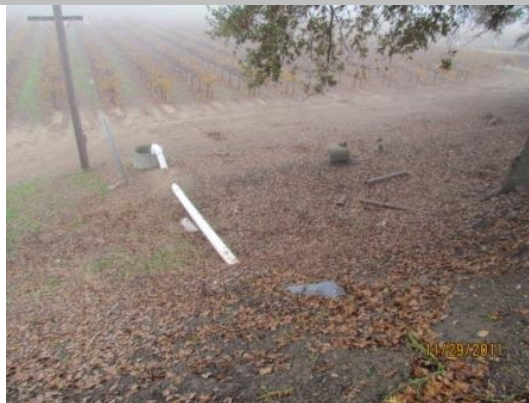
Photo 2 of 2 : SP\_2016\_RD0150\_16\_15\_20160219\_00011.jpg

A PVC pipe was used under the levee crown for irrigation purpose. The picture was taken from the crown looking downstream.

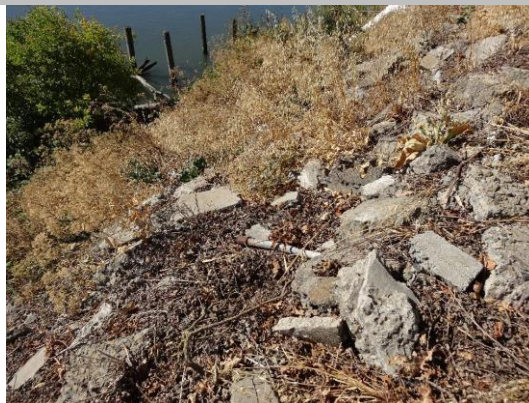
Photo 1 of 2 : UCIP\_SP\_2016\_19848\_33734.jpg

WS view: abandoned 1-inch conduit on levee slope.

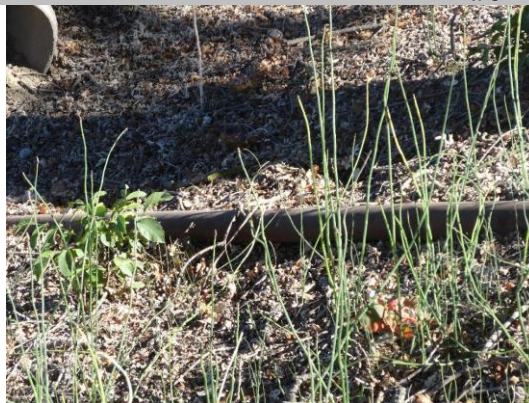
Photo 2 of 2 : UCIP\_SP\_2016\_19848\_33733.jpg

LS view: exposed 4-inch steel pipe on levee slope.

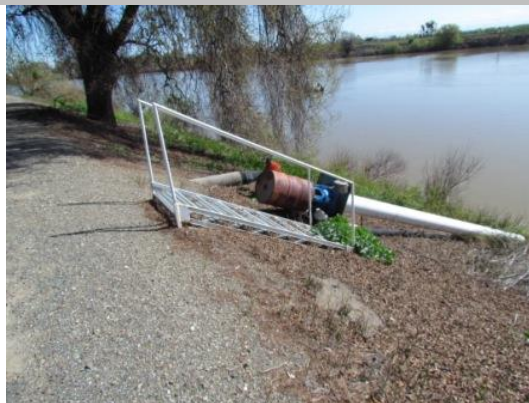
Photo 1 of 1 : SP\_2016\_RD0150\_16\_33\_20160219\_00019.jpg

A stairway was found on the waterside slope of the levee.

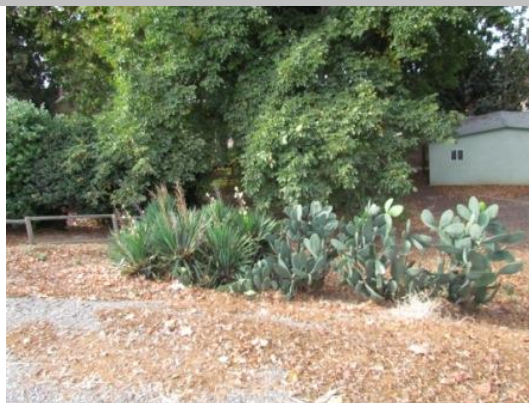
Photo 1 of 1 : SP\_2016\_RD0150\_16\_953\_20160219\_00046.jpg

View of cacti on the landside of the levee looking from the crown.

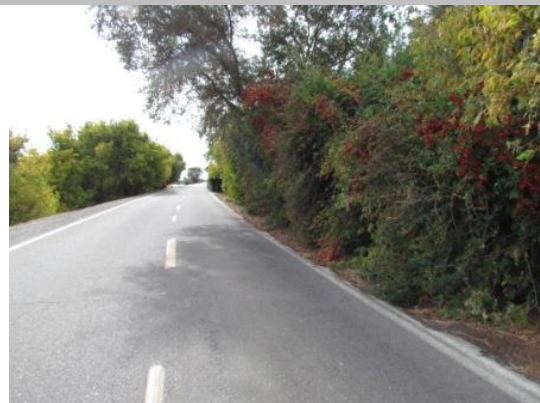
Photo 1 of 1 : SP\_2016\_RD0150\_16\_79\_20160219\_00039.jpg

Trees were obstructing the views on the landside slope of the levee looking downstream.

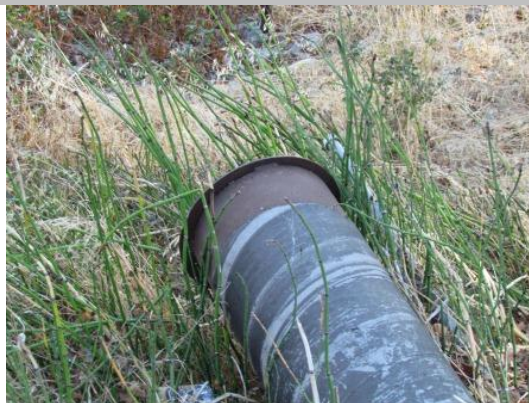
Photo 1 of 1 : SP\_2016\_RD0150\_16\_69\_20160219\_00036.jpg

The pipe cover doesn't appear to be water tight on the waterside slope of the levee. The picture was taken from the crown looking towards the toe of the levee during fall 2013 inspection.

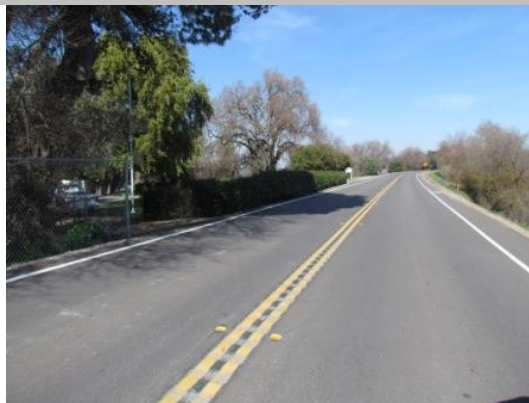
Photo 1 of 1 : SP\_2016\_RD0150\_16\_30\_20160219\_00017.jpg

Landscaping was found on the landside shoulder of the levee looking upstream.

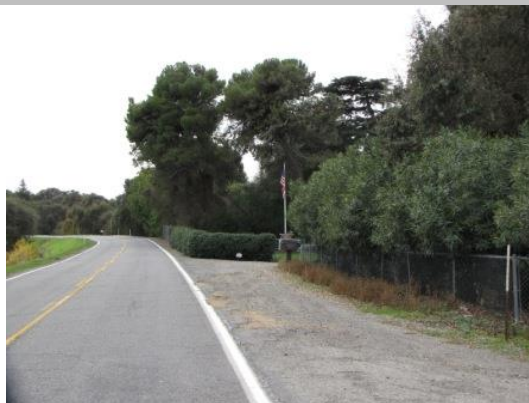
Photo 1 of 1 : SP\_2016\_RD0150\_16\_75\_20160219\_00037.jpg

View of landscaping along the landward shoulder and slope looking downstream.

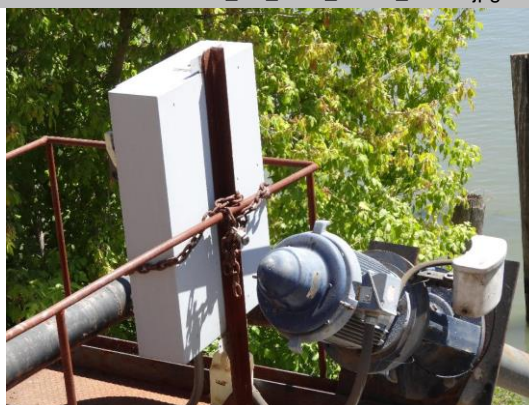
Photo 2 of 2 : UCIP\_SP\_2016\_20740\_34940.jpg

WS view: pipe, slant pump &amp; pump platform on stream bank.

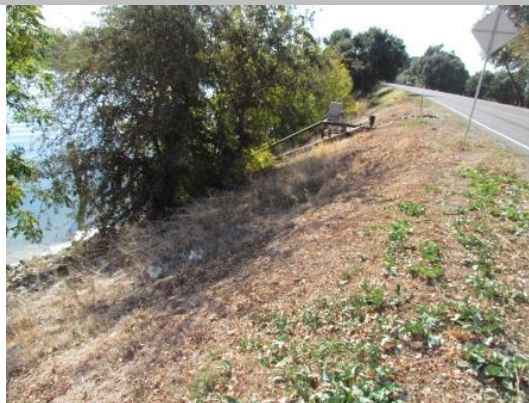
Photo 1 of 2 : SP\_2016\_RD0150\_16\_975\_20160219\_00052.jpg

View of minor slope instability on the waterside slope of the levee looking downstream during fall 2013 inspection.

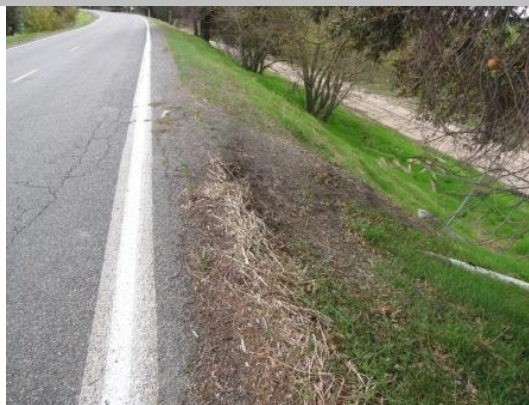
Photo 2 of 2 : SP\_2016\_RD0150\_16\_975\_20160219\_00053.jpg

View of a minor depression along the landward slope of the levee over a pipe penetration looking downstream.

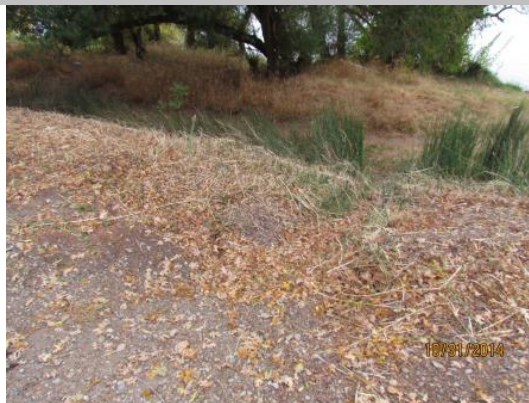
Photo 1 of 1 : SP\_2016\_RD0150\_16\_54\_20160219\_00029.jpg

View of a slope instability on the waterside of the levee looking towards the toe.

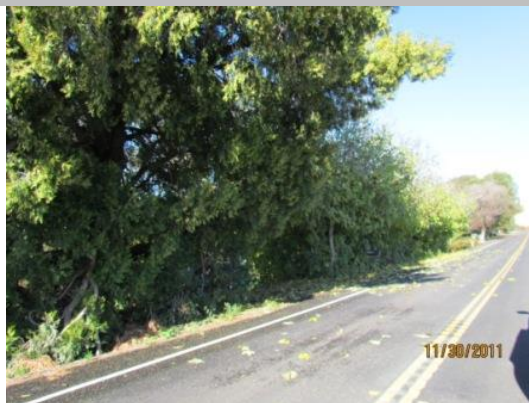
Photo 1 of 1 : SP\_2016\_RD0150\_16\_31\_20160219\_00018.jpg

Trees need to be trimmed on the landside of the levee looking upstream.

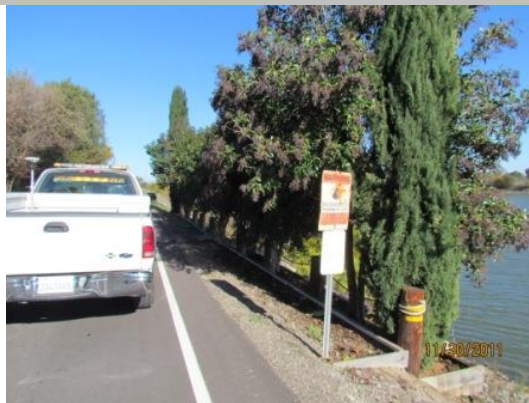
Photo 1 of 1 : SP\_2016\_RD0150\_16\_34\_20160219\_00020.jpg

Landscaping was found on the waterside of the levee looking upstream.

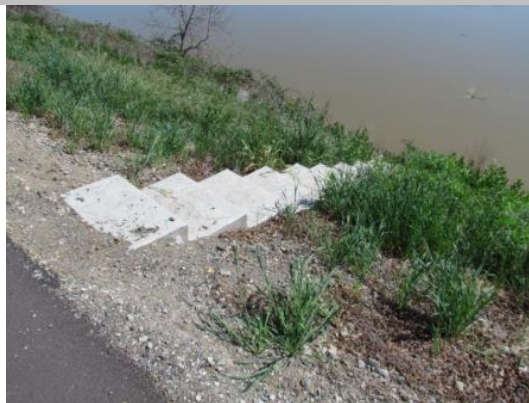
Photo 1 of 1 : SP\_2016\_RD0150\_16\_42\_20160219\_00022.jpg

A stairway was found on the waterside slope of the levee looking upstream.

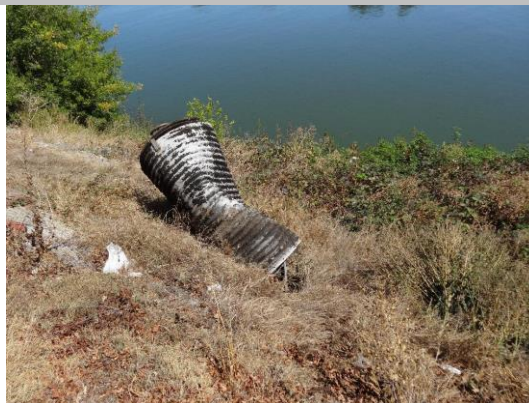
Photo 1 of 2 : UCIP\_SP\_2016\_20754\_34985.jpg

WS view: an abandoned and dismantled CMP riser on WS levee slope.

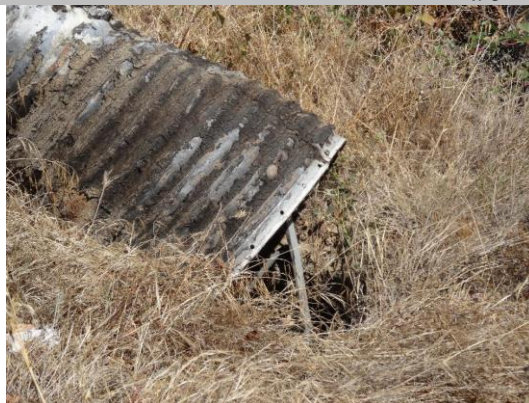
Photo 2 of 2 : UCIP\_SP\_2016\_20754\_34984.jpg

WS view: closer view of an abandoned and dismantled CMP riser on WS levee slope.

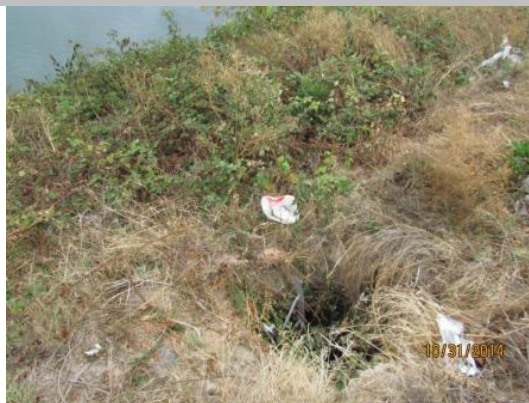
Photo 1 of 1 : SP\_2016\_RD0150\_16\_55\_20160219\_00030.jpg

An open pipe valve was found without a cover on the waterside toe of the levee.

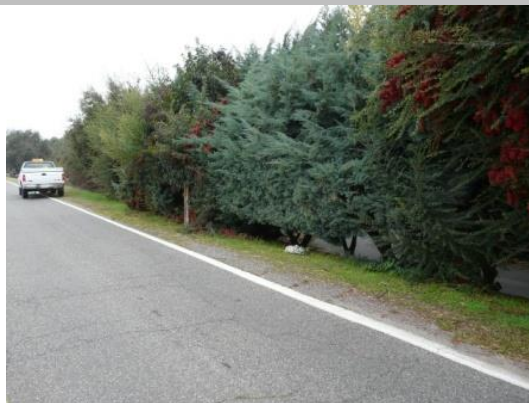
Photo 1 of 1 : SP\_2016\_RD0150\_16\_64\_20160219\_00034.jpg

Landscaping providing a screen for a residence on landside of levee from LM 6.68 to LM 6.72

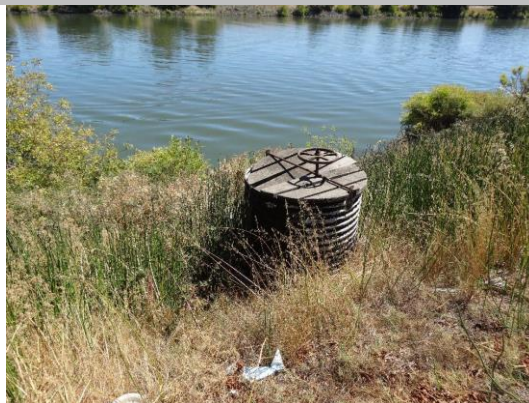
Photo 1 of 2 : UCIP\_SP\_2016\_41720\_34081.jpg

WS view: CMP riser with gate valve on levee slope. Dense vegetation on levee slope and stream bank.

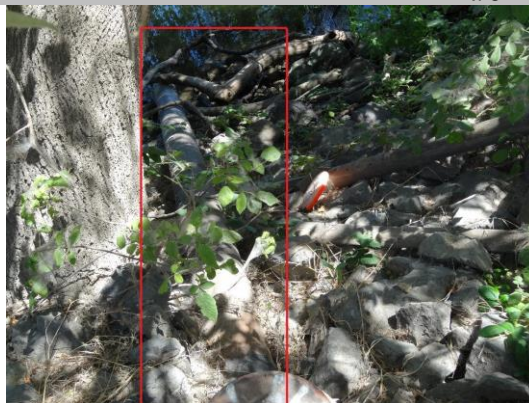
Photo 1 of 2 : UCIP\_SP\_2016\_41646\_34102.jpg

WS view: inlet steel pipe on stream bank.

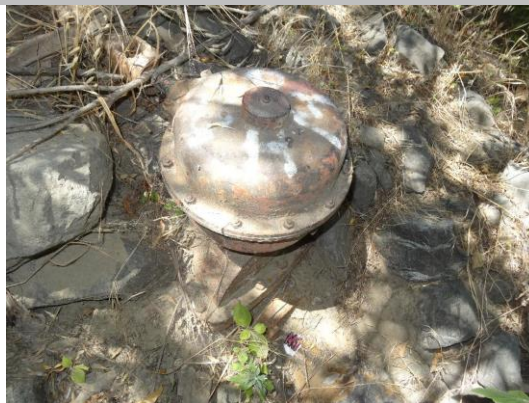
Photo 2 of 2 : UCIP\_SP\_2016\_41646\_34101.jpg

WS view: An abandoned old gate valve on inlet steel pipe on stream bank.

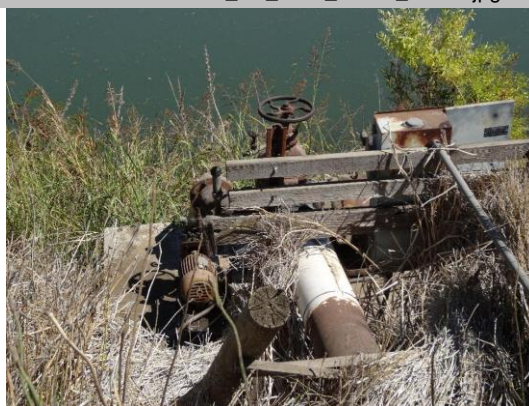
Photo 1 of 2 : UCIP\_SP\_2016\_42903\_35002.jpg

WS view: steel pipe, electric conduit, gate valve, and pump on levee slope.

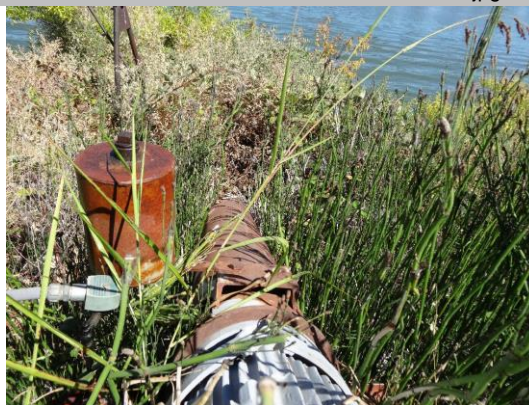
Photo 2 of 2 : UCIP\_SP\_2016\_20203\_34161.jpg

WS view: steel intake pipe and pump on levee slope. Dense vegetation on levee slope.

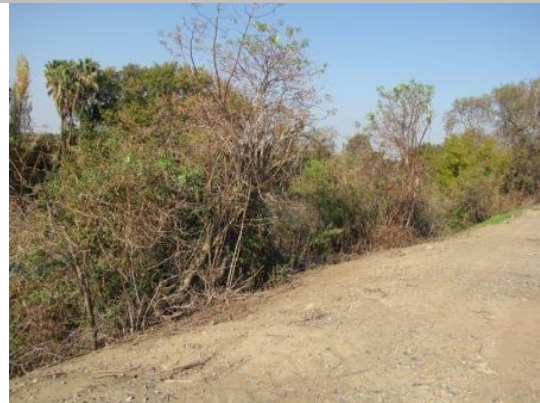
Photo 1 of 1 : SP\_2016\_RD0150\_17\_936\_20160219\_00097.jpg

View of elderberry bush within 20 feet of shoulder blocking visibility and access.

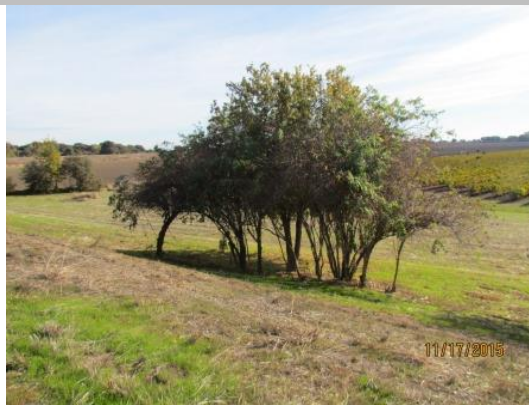
Photo 1 of 1 : SP\_2016\_RD0150\_17\_5\_20160219\_00005.jpg

View of elderberries on the landward slope of the levee.

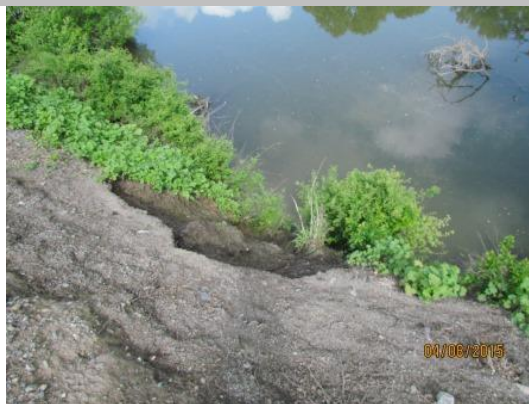
Photo 1 of 2 : SP\_2016\_RD0150\_17\_40\_20160219\_00033.jpg

Updated picture of the erosion on the waterside of the levee during spring 2015 inspection.

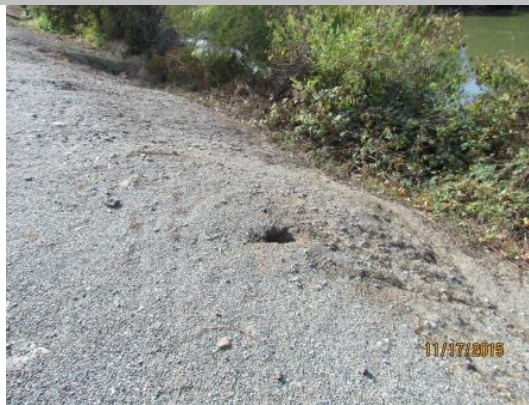
Photo 1 of 1 : SP\_2016\_RD0150\_17\_42\_20160219\_00035.jpg

View of a rodent hole on the waterside of the levee.

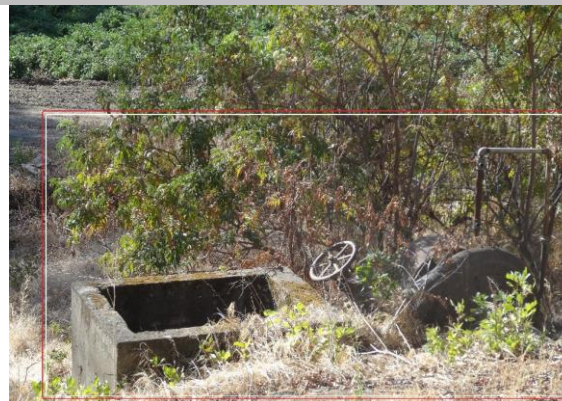
Photo 2 of 2 : UCIP\_SP\_2016\_19283\_32564.jpg

LS view: abandoned pump set and concrete box on levee slope.

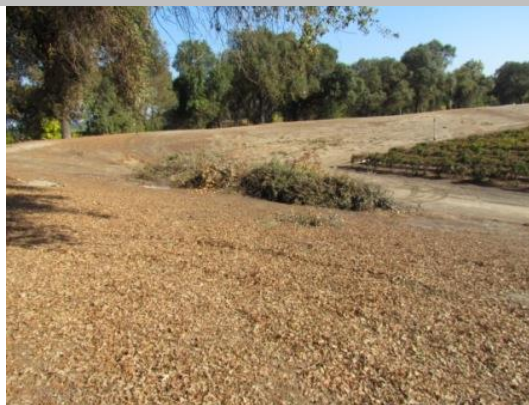
Photo 4 of 4 : SP\_2016\_RD0150\_17\_12\_20160219\_00012.jpg

Pruning was found on the landside toe of the levee looking upstream. This picture was taken during fall 2012 inspection.

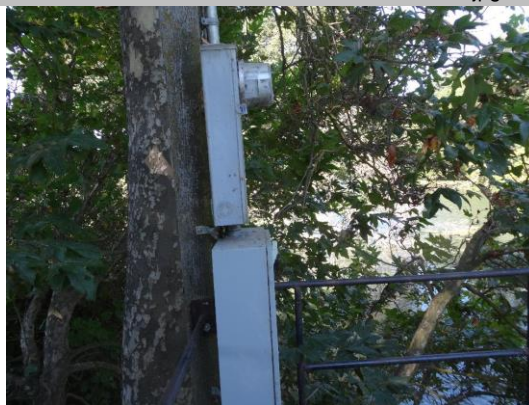
Photo 2 of 2 : UCIP\_SP\_2016\_28265\_51973.jpg

WS view: electric control box and power pole.

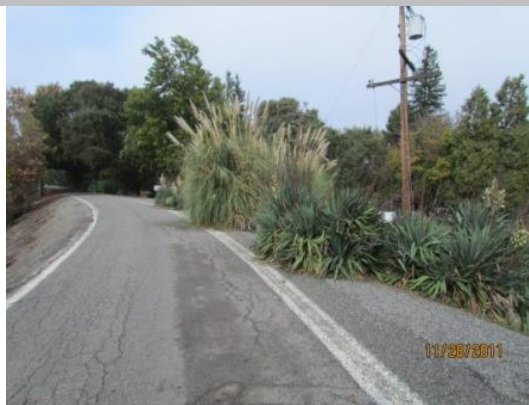
Photo 1 of 1 : SP\_2016\_RD0150\_17\_21\_20160219\_00017.jpg

Landscaping was found on the landside of the levee looking upstream.

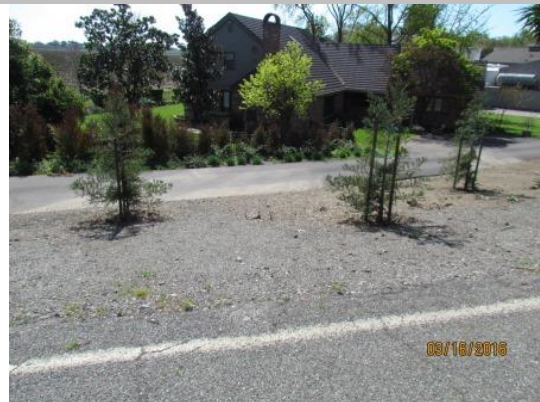
Photo 1 of 1 : SP\_2016\_RD0150\_17\_99\_20160321\_00151.jpg

View of newly planted tree on the landside slope of the levee.

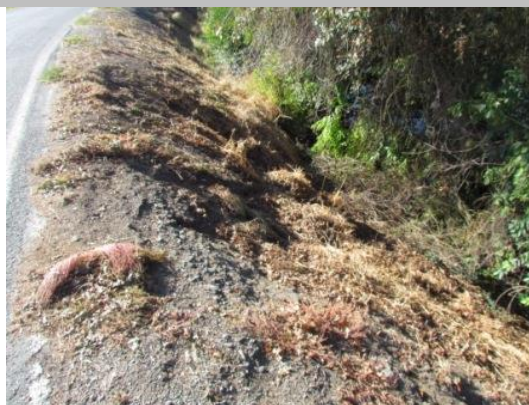
Photo 1 of 1 : SP\_2016\_RD0150\_17\_43\_20160219\_00036.jpg

Slope instability was found on the waterside of the levee looking downstream.

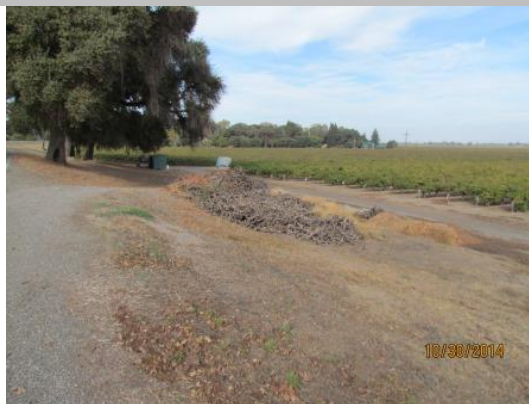
Photo 1 of 1 : SP\_2016\_RD0150\_17\_83\_20160219\_00078.jpg

Prunings were found on the landside toe of the levee looking upstream.

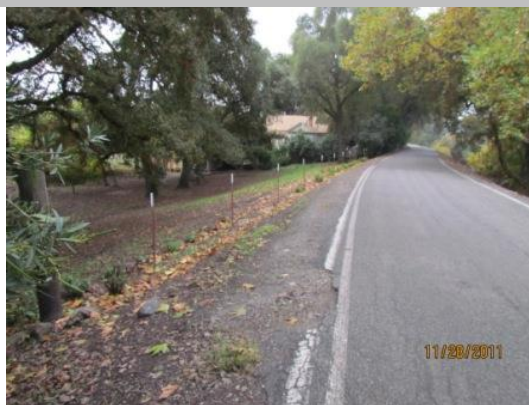
Photo 1 of 1 : SP\_2016\_RD0150\_17\_13\_20160219\_00013.jpg

Fence was found on the landside of the levee looking downstream.

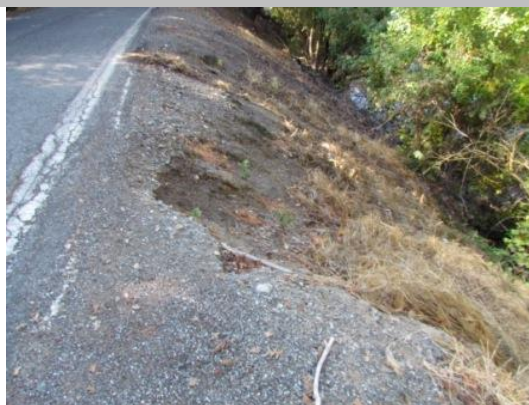
Photo 2 of 2 : SP\_2016\_RD0150\_17\_61\_20160219\_00058.jpg

Erosion was found on the waterside slope of the levee looking downstream. This updated picture was taken during fall 2012 inspection.

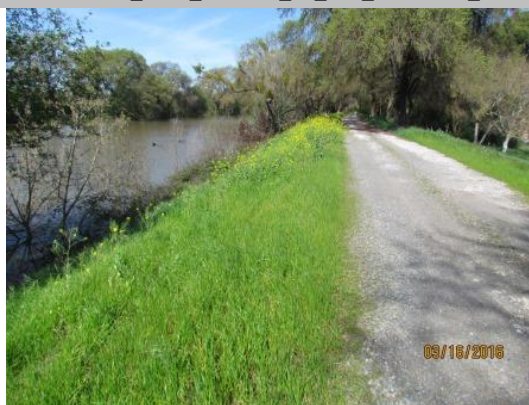
Photo 1 of 1 : SP\_2016\_RD0150\_17\_100\_20160321\_00152.jpg

View of the vegetation on the waterside slope of the levee looking upstream.

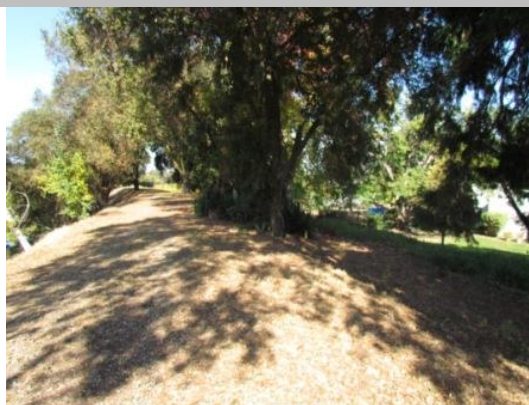
Photo 1 of 1 : SP\_2016\_RD0150\_17\_84\_20160219\_00079.jpg

Landscaping was found on the landside shoulder of the levee looking upstream.

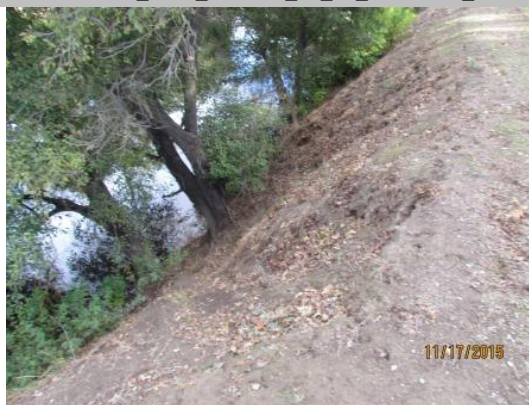
Photo 1 of 1 : SP\_2016\_RD0150\_17\_65\_20160219\_00063.jpg

View of erosion on the waterside of the levee.

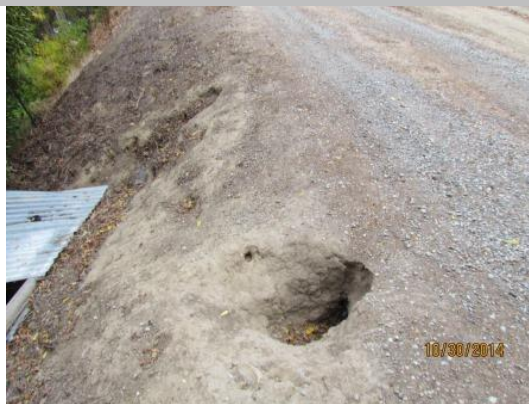
Photo 2 of 2 : SP\_2016\_RD0150\_17\_89\_20160219\_00082.jpg

Updated picture of a rodent hole on the waterside shoulder of the levee during fall 2014 inspection.

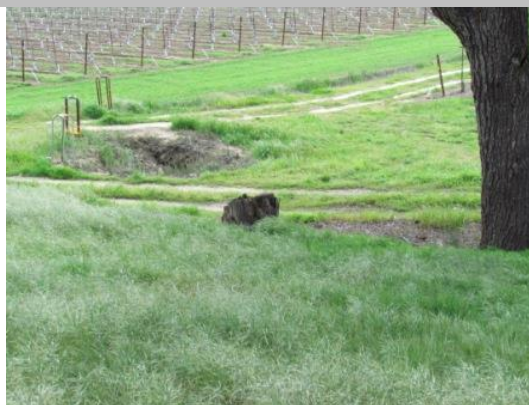
Photo 1 of 1 : SP\_2016\_RD0150\_17\_90\_20160219\_00083.jpg

A tree stump was found on the landside of the levee looking upstream.

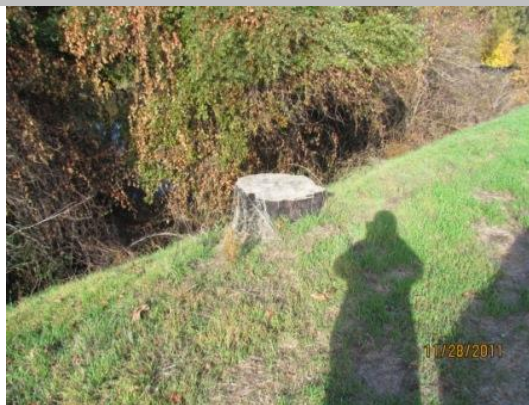
Photo 1 of 1 : SP\_2016\_RD0150\_17\_55\_20160219\_00051.jpg

A tree stump was found on the waterside of the levee looking upstream.
